Home Inspection Report

Client(s): Bob Smith
Property address: 8525 Happy Ln.
Anytown, USA
Inspection date: Friday, August 01, 2014

Report number: SE082014A

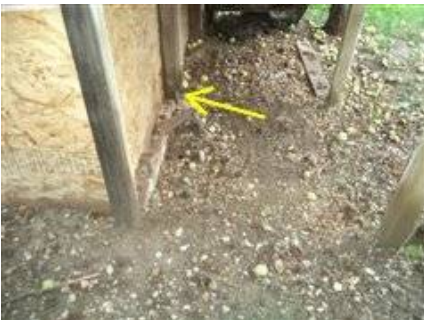
Photo 11-1East side of home

One or more wooden deck members are in contact with soil. This is a conducive condition for wood destroying insects and organisms. However no damage from wood destroying insects or organisms was found. Standard building practices require that there be at least 6" of space between any wood and the soil below, even if the wood is treated. If possible, soil should be removed or graded so a 6" clearance is maintained. Otherwise recommend installing borate based [Impel rods](#) to prevent rot.

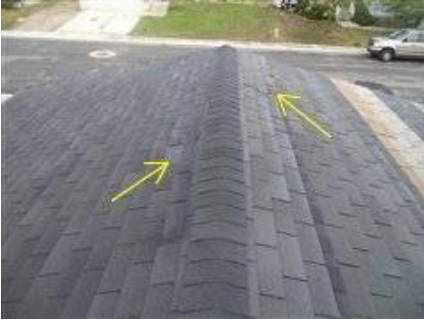
Photo 19-1
Roof

One or more composition shingles are damaged, deteriorated and/or missing or are installed in a substandard manner, and should be repaired or replaced. Leaks may occur as a result. A qualified roofing contractor should evaluate and make repairs as necessary.

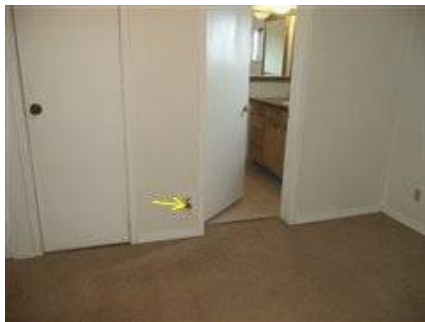
One or more open ground, three-pronged grounding type receptacles were found.

Grounding type receptacles were first required in residential structures during the 1960s. Based on the age of this structure and/or the absence of 2-pronged receptacles, repairs should be made by a qualified electrician to repair the circuits as necessary so all receptacles are grounded as per standard building practices. Replacement of three-pronged receptacles with 2-pronged receptacles is not an acceptable solution.

Photo 24-1
Interior

Photo 24-2
Bedroom

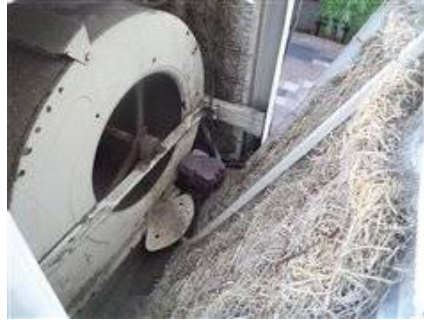
The evaporative cooler is deteriorated. The water pump is not functioning. Recommend a qualified professional evaluate and repair as necessary.

Photo 35-1
Roof

Photo 35-2
Roof, Interior of evaporative cooler

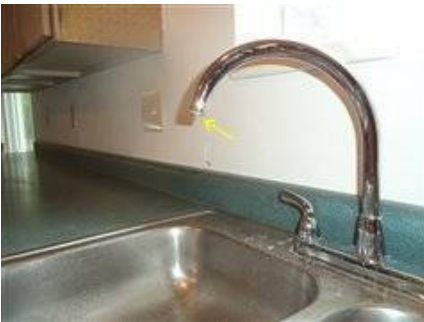
Photo 52-1
Kitchen

One or more faucet aerators are missing. Recommend cleaning or replacing aerators for better water flow.

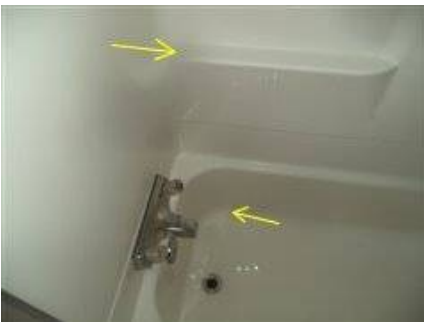
Photo 67-1
Bathroom

The enamel coating on one or more bathtubs is damaged and/or deteriorated. For example, chipped or worn, and/or rust on some exposed steel. However, no leaks were found due to the deterioration. The client(s) should evaluate to determine if the bathtub(s) should be refinished or replaced.
