Home Inspection Report

Client(s): Bob Smith
Property address: 8525 Happy Ln.
Anytown, USA
Inspection date: Friday, August 01, 2014

Report number: SE082014A

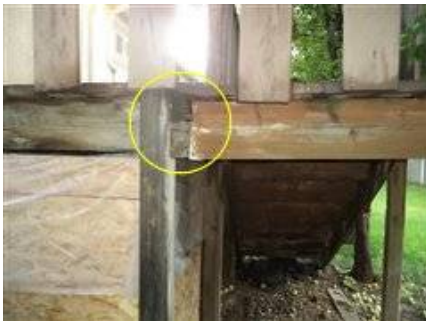
Photo 2-1
East side of home

The deck appears to have been constructed in a substandard manner or has deteriorated. For example, sagging, improper fasteners, hangers, brackets, bracing etc. Recommend a qualified contractor evaluate and make repairs as needed.

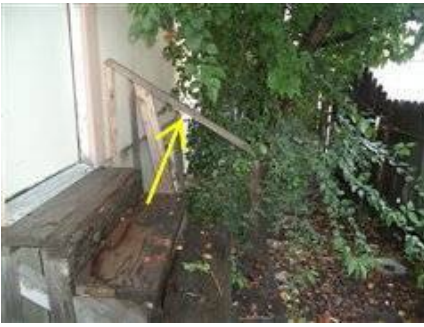
Photo 3-1
South side of home

Handrail(s) at some stairs are loose. This is a safety hazard. Make repairs as necessary. For example, installing new fasteners and/or hardware so handrails are securely attached.

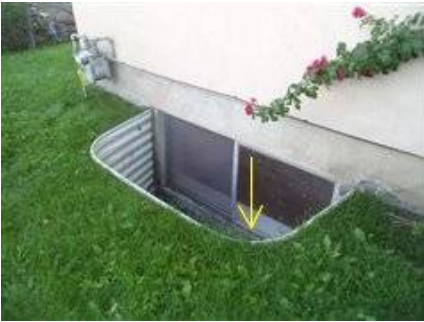
Photo 4-1
West side of home

This property has one or more deep window wells. This is a safety concern as small children can fall into the well and injure themselves. Recommend installing well coverings.

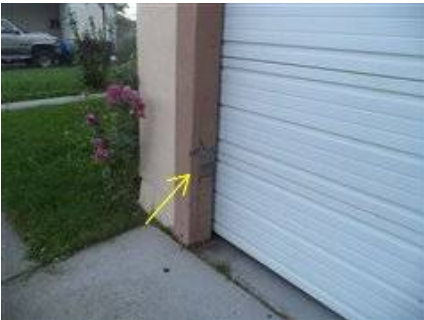
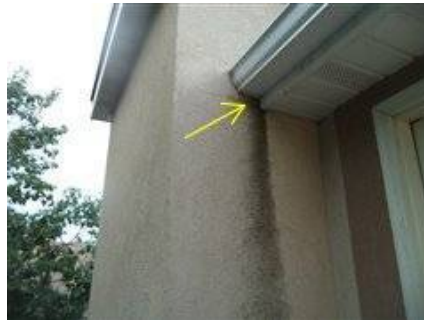
Cracks and staining was found in one or more areas of the stucco siding. This can be an indication that water is penetrating behind the siding. This is a condition conducive wood destroying insects and microbial growths and can cause damage to the structure over time. A qualified contractor should evaluate and make repairs and/or replace stucco siding as necessary.

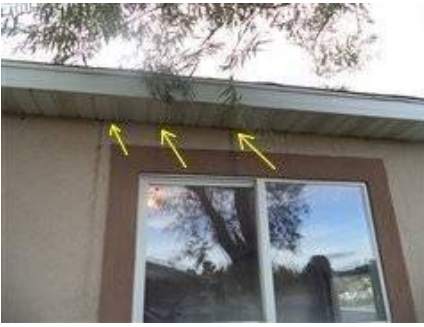
Photo 6-1
West side of home

Stains were found in one or more areas on soffit boards. These appear to be due to a lack of gutters (dripping water, high moisture content, etc.). A qualified contractor should evaluate and repair as necessary. Roof repairs may be necessary, such as to the roof surface and/or flashing. Drip edge flashing may need to be replaced or installed.

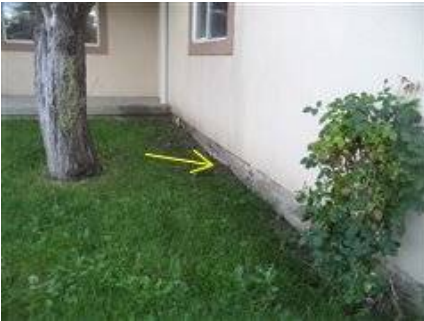
Photo 7-1
West side of home

- 7) 🛠️👁️ The perimeter grading slopes towards the structure in one or more areas or does not slope away from the structure. This can result in water accumulating around the structure's foundation, or in basements and crawl spaces if they exist. Accumulated water is a conducive condition to wood destroying insects and organisms. Wet soil may also cause the foundation to settle and possibly fail over time. Recommend grading soil so it slopes down and away from the structure with a slope of at least 5% (10% or better is optimal) for at least 6 feet.

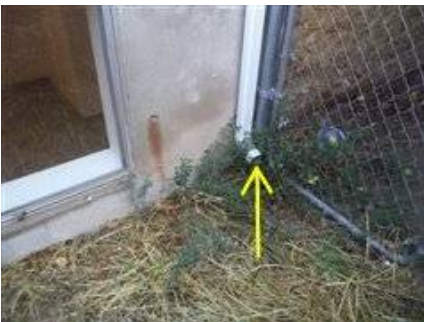
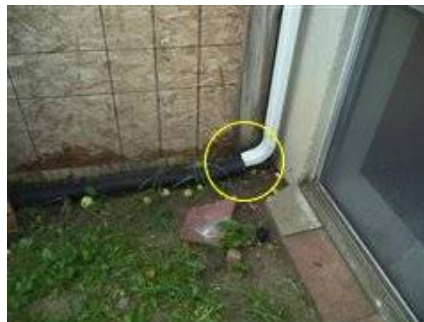
- 8) 🛠️👁️ One or more downspouts have no extensions, or have extensions that are ineffective. This can result in water accumulating around the structure's foundation, or in basements and crawl spaces if they exist. Accumulated water is a conducive condition to wood destroying insects and organisms, and may also cause the foundation to settle and possibly fail over time. Repairs should be made as necessary, such as installing or repositioning splash blocks, or installing and/or repairing tie-ins to underground drain lines, so rain water is carried at least several feet away from the structure to soil that slopes down and away from the structure.

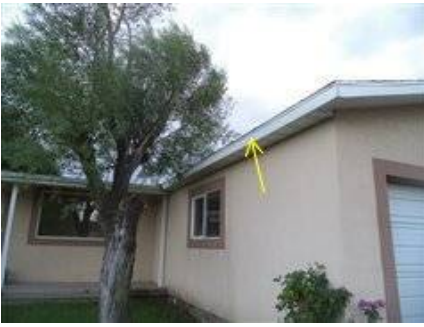
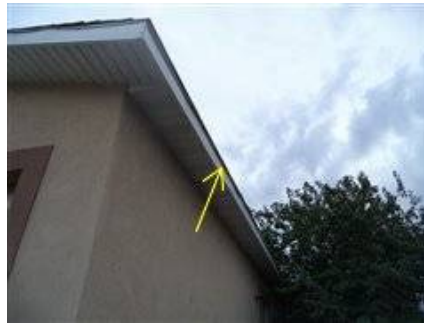
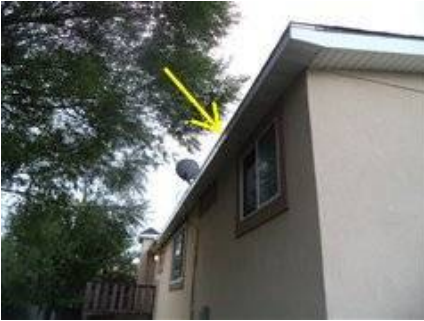
- 9) 🛠️👁️ One or more gutters are missing. This can result in water accumulating around the structure's foundation, or in basements and crawl spaces if they exist. Accumulated water is a conducive condition to wood destroying insects and organisms, and may also cause the foundation to settle and possibly fail over time. Gutters and downspouts should be installed where missing. Also, extensions such as splashblocks or tie-ins to underground drain lines should be installed as necessary to carry rain water away from the house.

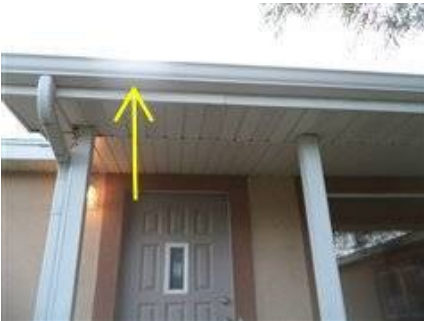
Photo 10-1
West side of home

One or more gutters were leaking during the inspection. This can result in water accumulating around the structure's foundation, or in basements and crawl spaces if they exist. Accumulated water is a conducive condition to wood destroying insects and organisms, and may also cause the foundation to settle and possibly fail over time. Replace or repair gutters where necessary.

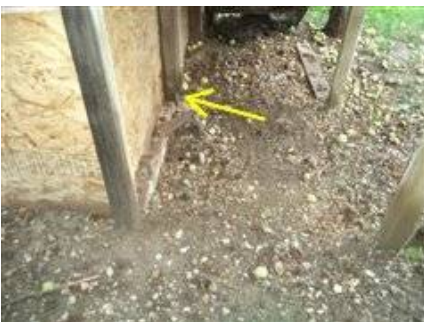
Photo 11-1East side of home

One or more wooden deck members are in contact with soil. This is a conducive condition for wood destroying insects and organisms. However no damage from wood destroying insects or organisms was found. Standard building practices require that there be at least 6" of space between any wood and the soil below, even if the wood is treated. If possible, soil should be removed or graded so a 6" clearance is maintained. Otherwise recommend installing borate based [Impel rods](#) to prevent rot.

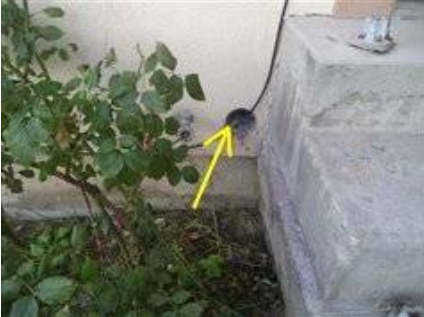
**Photo 12-1**West side of home

One or more exhaust duct end caps are damaged and/or deteriorated. Their purpose is to prevent unconditioned air from entering the house, and keep out birds, rodents and bugs. Blocked ducts can cause fan motors and/or clothes dryers to overheat and may pose a fire hazard. New vent cap(s) should be installed where necessary.

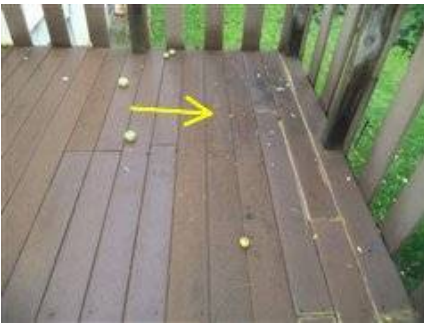
**Photo 14-1**East side of home

Composite decking is deteriorated in some areas. Repair or replace as needed.

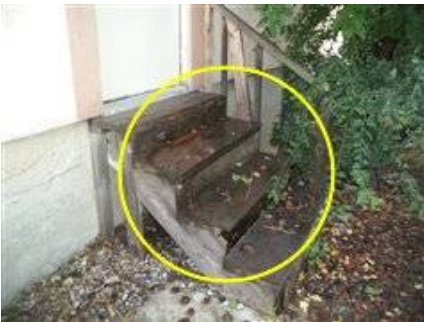
**Photo 15-1**South side of home

Significant rot was found in support posts, bracing at one or more structures covering decks, patios and/or porches. Recommend that a qualified person repair as necessary. All rotten wood should be replaced.

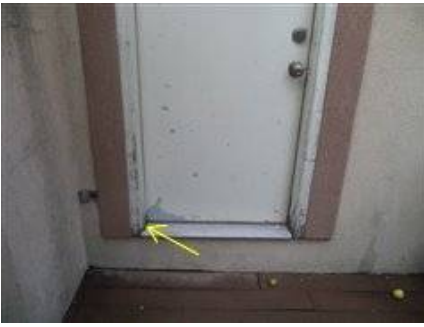
Photo 16-1
East side of home

The painted exterior finish in some areas is failing. These areas should be prepped (pressure wash, scrape, sand, prime caulk, etc.) and repainted as needed and as per standard building practices.

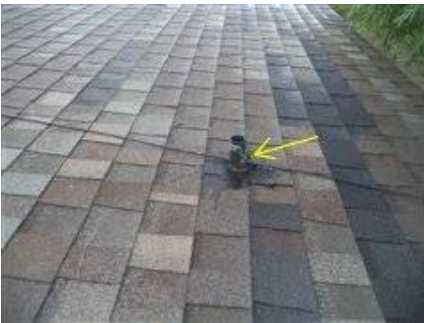
Photo 17-1
Roof

One or more plumbing vent pipes terminate less than six inches above the roof surface below. Debris or snow may block openings, and may result in sewer gases entering living spaces. A qualified contractor should evaluate and make repairs as necessary so vent pipes terminate at least six inches above roof surfaces.

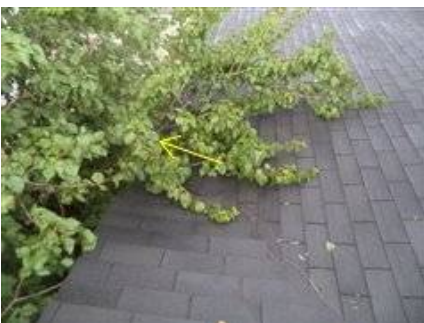
Photo 18-1
Roof

Trees and/or shrubs are in contact with the roof edge(s) in one or more areas. Some damage has occurred. A qualified contractor should evaluate and make repairs as necessary. Vegetation should be pruned back and/or removed as necessary to prevent damage and infestation by wood destroying insects.

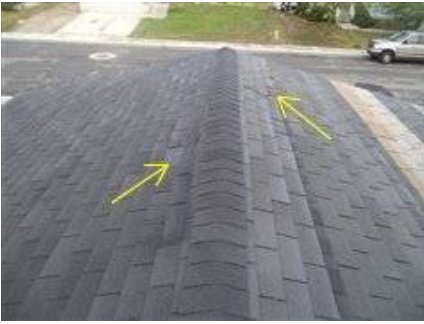
Photo 19-1
Roof

One or more composition shingles are damaged, deteriorated and/or missing or are installed in a substandard manner, and should be repaired or replaced. Leaks may occur as a result. A qualified roofing contractor should evaluate and make repairs as necessary.

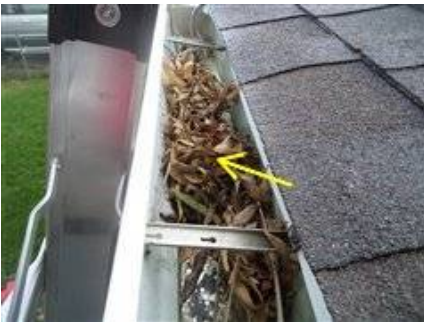
Photo 20-1
Roof

Debris has accumulated in one or more gutters. This is a conducive condition for wood destroying insects since gutters may overflow and cause water to come in contact with the structure's exterior or make water accumulate around the foundation. Gutters should be cleaned now and as necessary in the future.

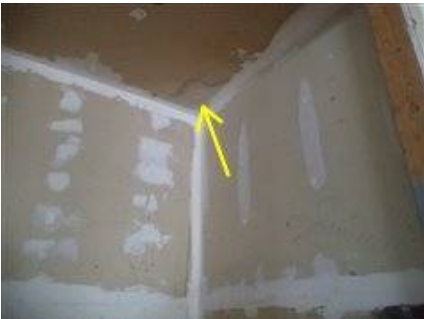
Photo 22-1
Garage

22) Stains and/or water damage was found in one or more ceiling and/or wall areas. However, no elevated levels of moisture were found. The stain(s) or damage may be due to past roof and/or plumbing leaks. Recommend asking the property owner(s) about this, and monitoring the area(s) in the future, especially after heavy or prolonged rain. If elevated moisture is found in the future, a qualified contractor should evaluate and repair as necessary.

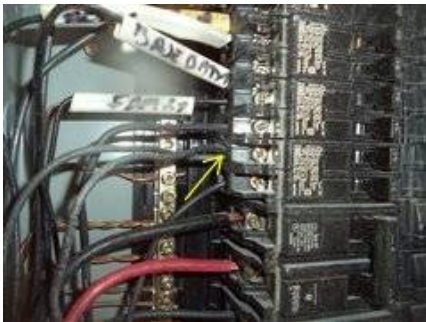
Photo 23-1
Bedroom

One or more overcurrent protection devices (circuit breakers or fuses), neutral terminations and/or lugs are "double tapped", where 2 or more wires are clamped in a terminal designed for only one wire. This is a safety hazard since the bolt or screw may tighten securely against one wire, but leave others loose. Arcing, sparks and fires may result. A qualified electrician should evaluate and repair as necessary.

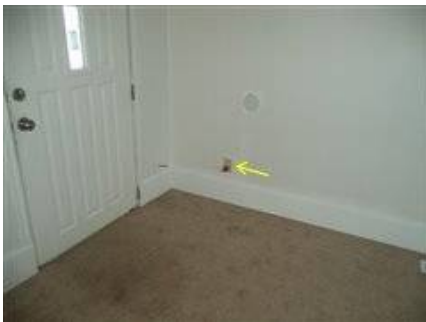
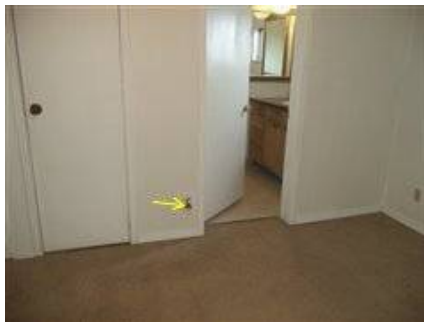
One or more open ground, three-pronged grounding type receptacles were found.

Grounding type receptacles were first required in residential structures during the 1960s. Based on the age of this structure and/or the absence of 2-pronged receptacles, repairs should be made by a qualified electrician to repair the circuits as necessary so all receptacles are grounded as per standard building practices. Replacement of three-pronged receptacles with 2-pronged receptacles is not an acceptable solution.

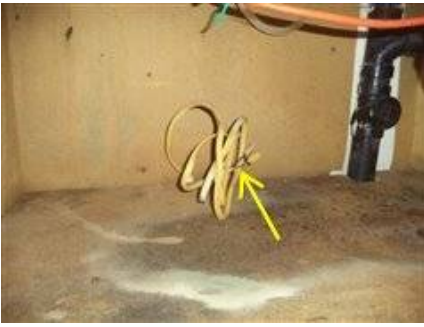
Photo 25-1
Basement kitchen

One or more sections of wiring that weren't terminated were found. This is a potential safety hazard due to the risk of shock. A qualified electrician should evaluate and repair as necessary. For example, cutting the wire to length and terminating the wire with wire nuts in a securely anchored, covered, properly sized junction box or install light fixture or other device.

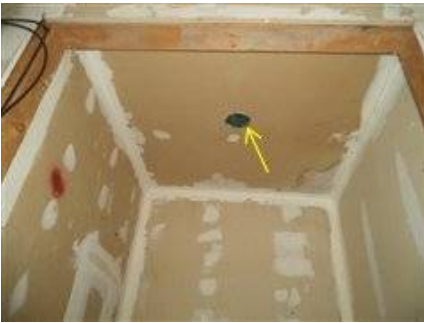
Photo 26-1
Garage

Wire splices are exposed due to not being contained in a covered junction box. This is a safety hazard due to the risk of shock and fire. A qualified electrician should evaluate and make repairs as necessary. For example, install securely mounted junction boxes with cover plates where needed to contain wiring splices.

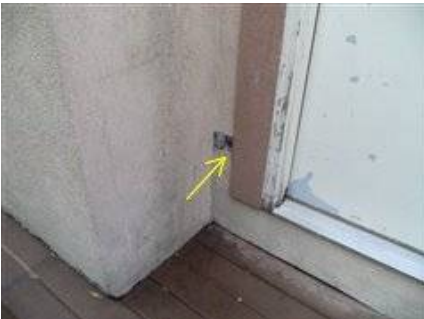
Photo 27-1
East side of home

One or more electric receptacles that serve countertop surfaces within six feet of a sink or serve the exterior or garage appear to have no ground fault circuit interrupter (GFCI) protection. This is a safety hazard due to the risk of shock. A qualified electrician should evaluate to determine if GFCI protection exists, and if not, repairs should be made so that all receptacles that serve countertop surfaces within six feet of sinks have GFCI protection. For example, install GFCI receptacles or circuit breaker(s) as needed. Note: GFCI receptacles were not introduced until 1971. They began to be required in bathrooms in 1975 and in kitchens in 1987.

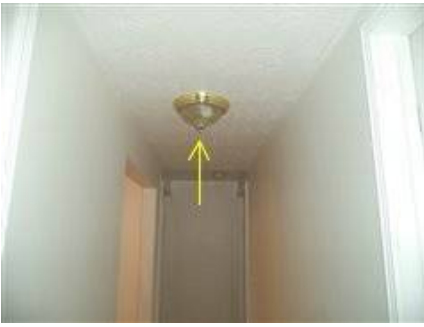
Photo 28-1
Basement hallway

The light fixture in one or more rooms, hallways or stairs is controlled by a single switch at one end or entry or inoperable 3-way switches (for example, only the switch that turns out the light can turn it back on). This is a safety hazard due to inadequate lighting. The light should be controlled by functioning three-way switches near each entry. A qualified electrician should evaluate and make repairs as necessary.

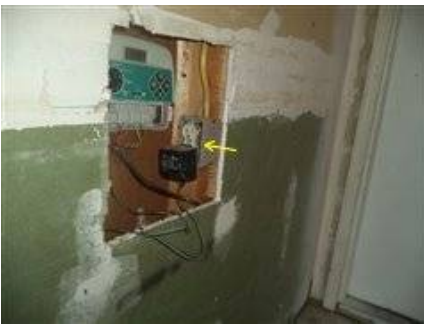
Photo 29-1
Garage

29) 🛠️🔌🔧 Cover plate(s) are missing from one or more electric boxes, such as for receptacles, switches and/or junction boxes. They are intended to contain fire and prevent electric shock from exposed wires. This is a safety hazard due to the risk of fire and shock. Cover plates or fixtures should be installed where missing.

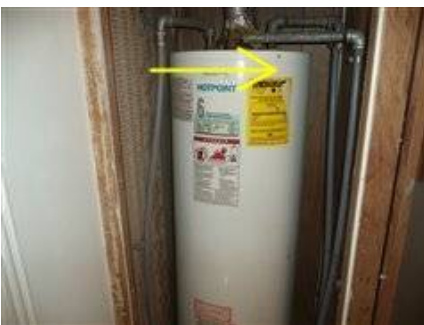
Photo 30-1
Mechanical area

30) 🛠️🔧 The water heater does not have seismic straps or struts installed. This is a potential safety hazard since movement can cause leaks in the gas supply lines or damage wiring. Leaks may also occur in water supply pipes. Install seismic straps or struts as necessary and as per standard building practices.

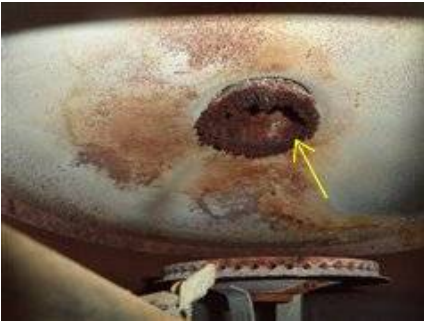
Photo 32-1
Mechanical area

Corrosion was found in one or more areas on the water heater. The water heater may be beginning to fail. A qualified plumbing contractor should evaluate and replace or repair water heater if necessary.

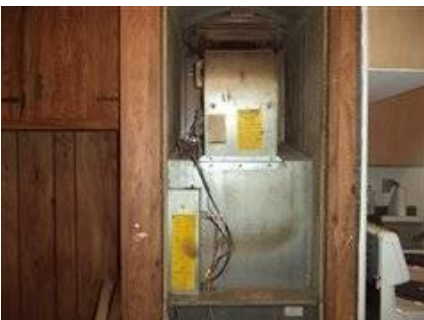
Photo 34-1
Mechanical area

Because of the age and/or condition of this furnace, recommend that a qualified heating and cooling technician inspect the heat exchanger and perform a Carbon Monoxide test when it's serviced.

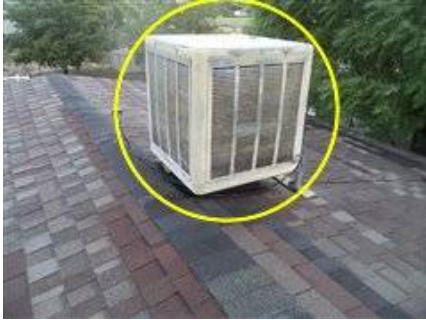
Photo 35-1

The evaporative cooler is deteriorated. The water pump is not functioning. Recommend a qualified professional evaluate and repair as necessary.

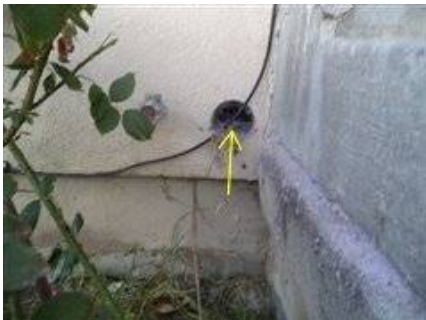
Photo 38-1

The clothes dryer exhaust duct appears to need cleaning. Significant amounts of lint build up was found. This is a safety hazard due to the risk of fire from decreased air flow. This duct should be cleaned now and annually, or more often if necessary in the future. Some chimney sweeps or heating/cooling duct cleaners perform this service. For more information, visit <http://www.cpsc.gov/CPSCPUB/PUBS/5022.html> or <http://chimneykeepers.com/dryerclean.html>

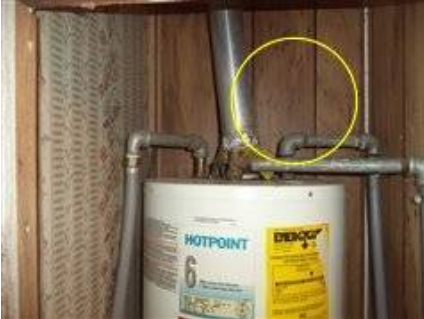
Photo 39-1
Mechanical area

No expansion tank is installed on this structure's water supply system. Expansion tanks are recommended when a property is on a public water supply system and the property's water system is "closed" via a pressure reducing valve (PRV), check valve, or backflow preventer. No room for expansion of water exists in this type of system. Thermal expansion occurs when water is heated during non-use

- Backflow into the water main
- Damage to water heater connections, gas water heater flue tubes and pumps serving washers and dishwashers
- Leaking faucets
- "Weeping" of water through the water heater temperature-pressure relief (TPR) valve
- Noisy water hammer in the pipes.

Expansion tanks can eliminate these problems by giving water a place to go when thermal expansion occurs. When a water heating cycle ends, or when any fixture is opened within the system, the impact of thermal expansion is reduced, and water drains out of the expansion tank back into the system. Recommend having a qualified plumber install an expansion tank as per standard building practices.

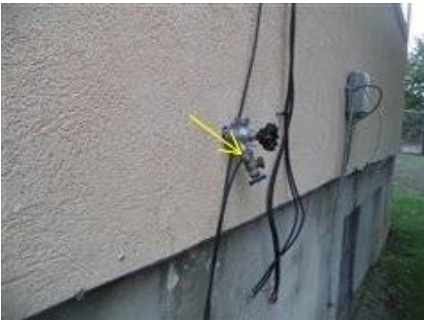
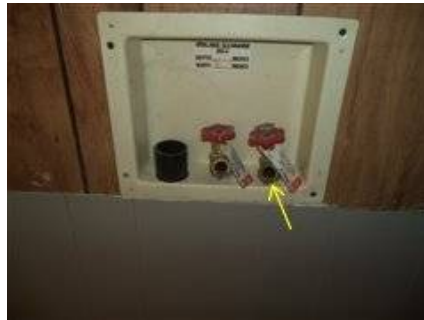
One or more leaks were found in water supply valves. A qualified plumber should repair as necessary.

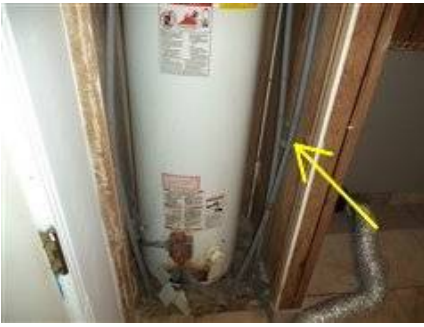
Photo 41-1
Mechanical area

Plumbing supply lines appear to be made of Polybutylene. Polybutylene is a plastic material used extensively during the 1980s and 1990s that has proven to be more prone to leakage than other types of supply piping systems like copper. A home inspection cannot determine if polybutylene pipes are about to leak simply by looking at the outside of them. Pipes deteriorate from the inside and can split under pressure. They can leak anytime without warning destroying furniture, family heirlooms, and even causing structural damage. Leaks can go unnoticed and lead to mold. Recommend reviewing any disclosure statements if available for comments on leaks in the water supply system.

A class action lawsuit has been filed regarding this material that requires the manufacturers to cover piping systems installed between Jan. 1, 1978 through July 31, 1995. For more information on the class action lawsuit, visit <http://www.pbpipe.com/index1.htm> , or call the Plumbing Claims Group at (800) 356-3496 for more information.

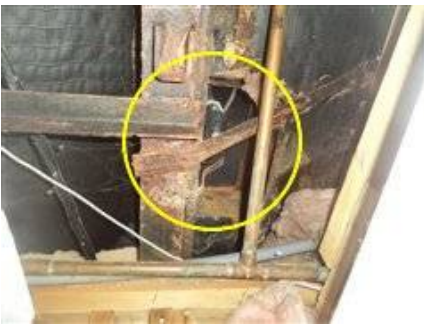
Photo 42-1
Basement, Under main floor bathroom

Stains were found in one or more sections of drain and/or waste pipes. Recommend monitoring these areas in the future, and if leaks are found, have a qualified plumber evaluate and repair as necessary. Alternatively, the client(s) may wish to have a qualified plumber evaluate now and repair if necessary.

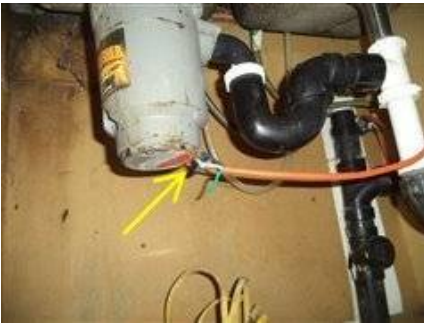
Photo 43-1
Basement kitchen

Substandard wiring was found for the under-sink food disposal. For example, unprotected solid-strand, non-metallic sheathed (Romex) wiring is used, open junction boxes, wire splices not in boxes etc. This is a safety hazard due to the risk of shock and fire. A qualified electrician should evaluate and repair as necessary.

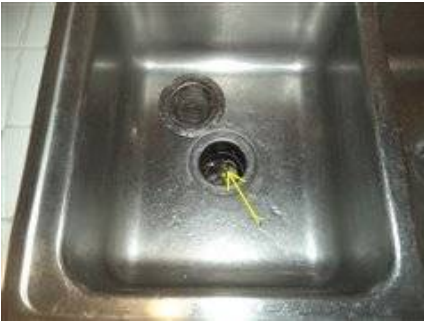
Photo 44-1
Basement kitchen

The rubber safety flap at garbage disposer entrance is missing and/or damaged. This device helps protect the user from items flying out of the disposer during operation. Recommend replacing flap.

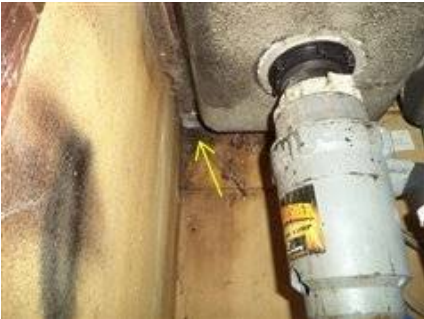
Photo 45-1
Basement kitchen

A suspicious microbial-growth was observed on floors, walls and/or ceilings. Typically these types of growths exist in moist areas where a food source such as wood or drywall is present. When the source of the moisture is removed these bio-growth cease to grow and can be eliminated through remediation. The EPA has determined that small areas (less than 10 square feet) can be cleaned by the homeowner using products such as Dow Scrubbing Bubbles or similar cleansers. Larger areas should be remediated by a professional. For more information visit www.epa.gov/iaq/molds

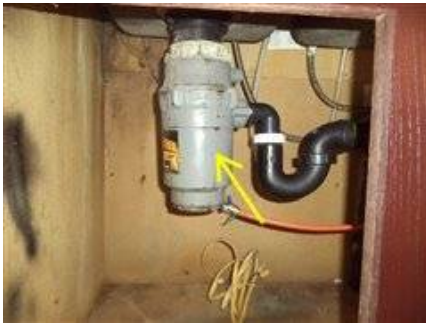
Photo 46-1
Basement kitchen

The under-sink food disposal is inoperable. A qualified plumber or contractor should evaluate and repair or replace the food disposal as necessary.

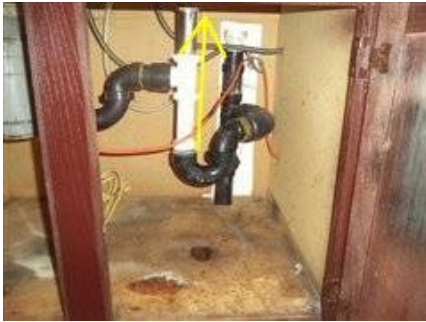
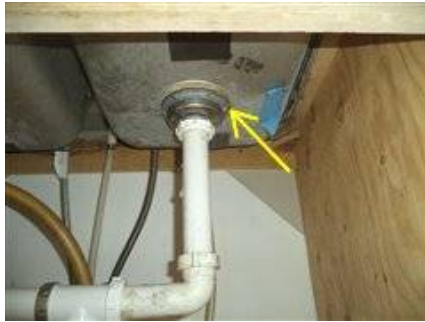
One or more toilets, tubs, sink drains or water supply lines have an active leak. For example, at pipe fittings and/or junctions between pipe and sink. A qualified plumber should evaluate and repair as necessary.

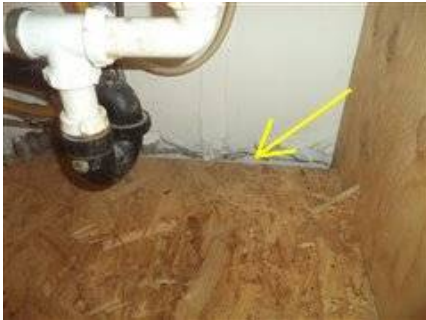
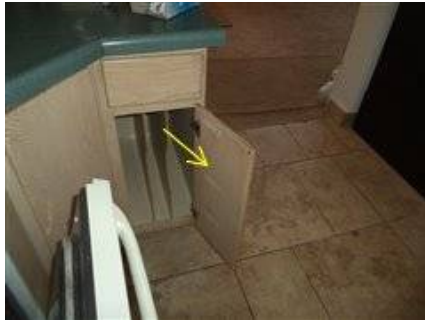
One or more cabinets, drawer, doors, hinges, shelving are damaged and/or deteriorated. Repair or replace components as necessary.

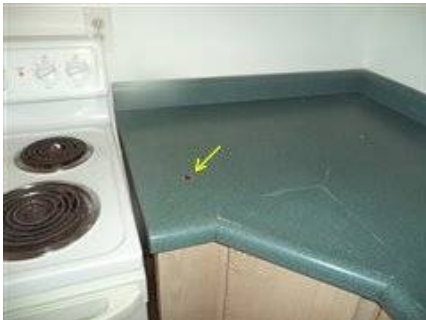
Photo 49-1

Countertops are damaged and/or deteriorated in one or more areas. Evaluate and repair or replace countertops as necessary.

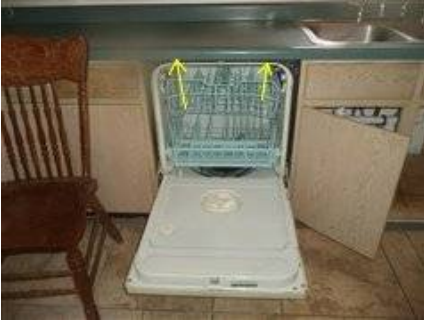
Photo 50-1
Kitchen

The bracket that attaches the dishwasher to the underside of the countertop is loose, missing or installed in a substandard way. Repairs should be made as necessary, such as installing or reinstalling the bracket.

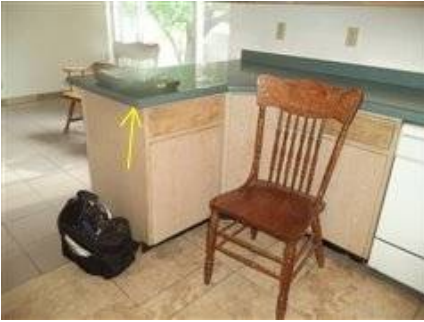
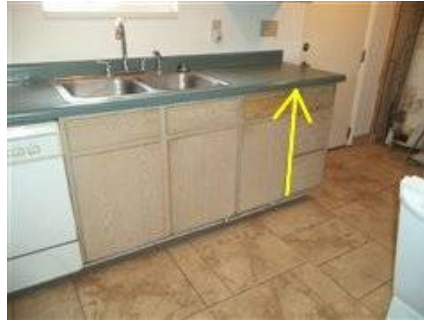
One or more counter tops are not securely fastened to the base below. Recommend installing anchors as needed to secure the countertop.

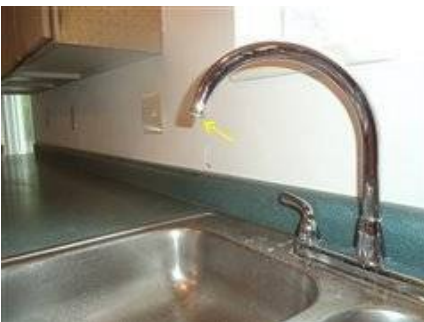
Photo 52-1
Kitchen

One or more faucet aerators are missing. Recommend cleaning or replacing aerators for better water flow.

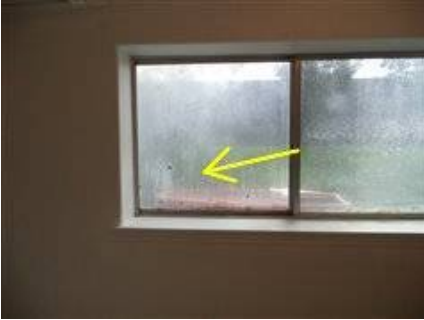
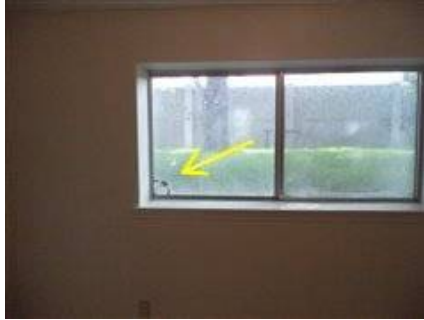
Glass in one or more windows is broken. A qualified contractor should replace glass where necessary.

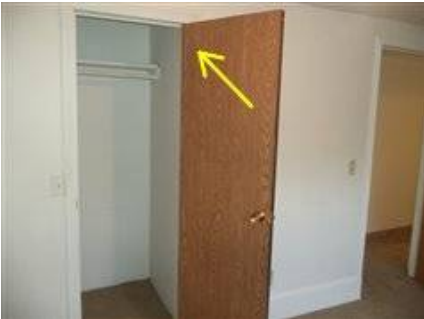
Photo 57-1
Basement bedroom

One or more interior doors, casings or trim are damaged and/or deteriorated and should be repaired or replaced as necessary.

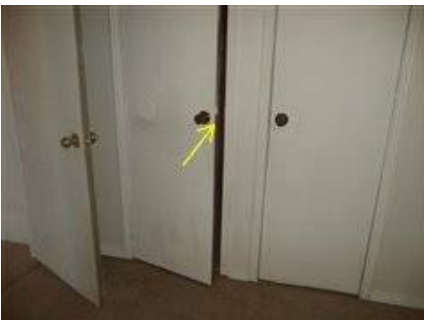
Photo 58-1
Interior

One or more doors will not latch when closed. Repairs should be made as necessary. For example, aligning strike plates with latch bolts and/or replacing locksets.

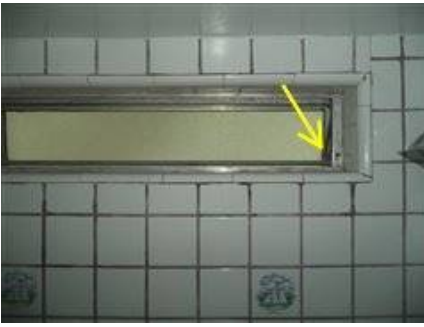
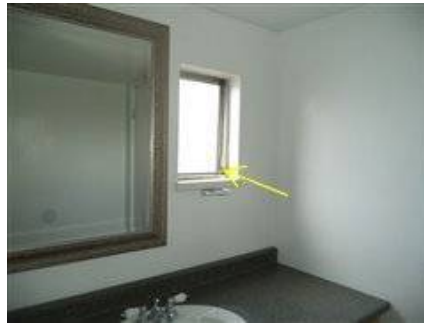
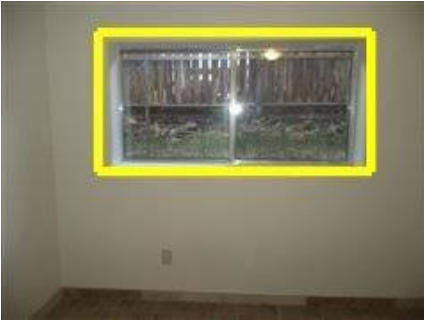
One or more windows are deteriorated. Recommend making repairs as needed.

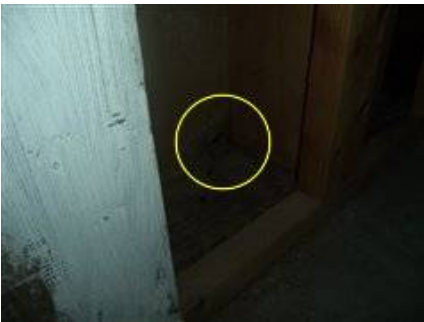
Photo 60-1
Basement bathroom, Behind or inside of wall behind basement kitchen

60) 🛠️🔍️ A suspicious microbial-growth was observed on floors, walls and/or ceilings. Typically these types of growths exist in moist areas where a food source such as wood or drywall is present. When the source of the moisture is removed these bio-growths cease to grow and can be eliminated through remediation. The EPA has determined that small areas (less than 10 square feet) can be cleaned by the homeowner using products such as Dow Scrubbing Bubbles or similar cleansers. Larger areas should be remediated by a professional. For more information visit www.epa.gov/iaq/molds

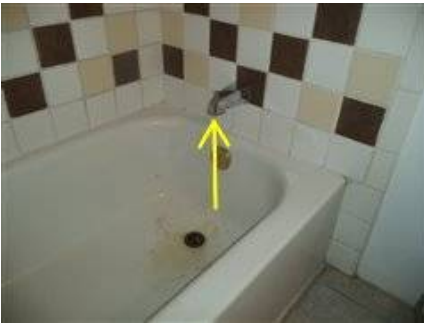
Photo 61-1
Basement bathroom

61) 🛠️🔍️ One or more faucets leak or drip when turned off. A qualified plumber should evaluate and repair as necessary.

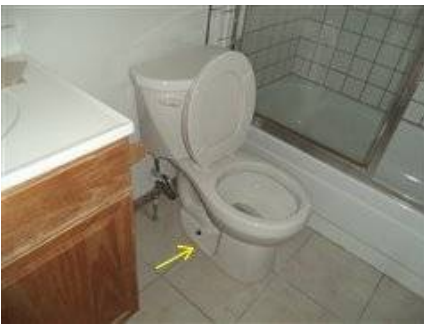
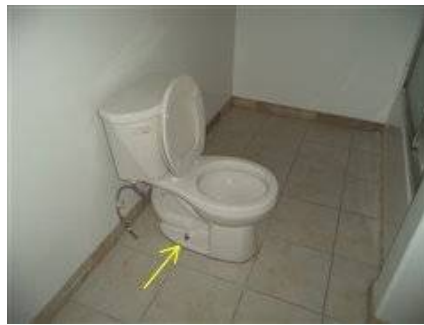
One or more toilets are loose. Although no moisture in the flooring around the toilet was detected, a qualified contractor should remove the toilet(s) for further evaluation and repairs if necessary. A new wax ring should be installed and toilet(s) should be securely anchored to the floor to prevent movement and leaking.

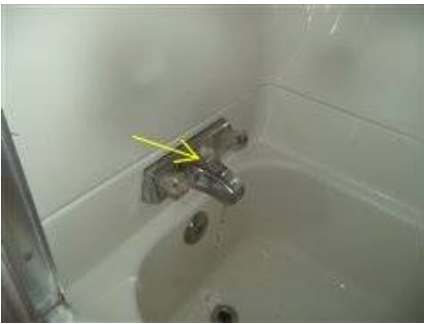
Photo 63-1
Bathroom

The shower diverter valve for one or more bathtub faucets is defective. A significant amount of water comes out of the bathtub spout when the shower is turned on. Water will be wasted as a result. A qualified plumber should evaluate and replace components or make repairs as necessary.

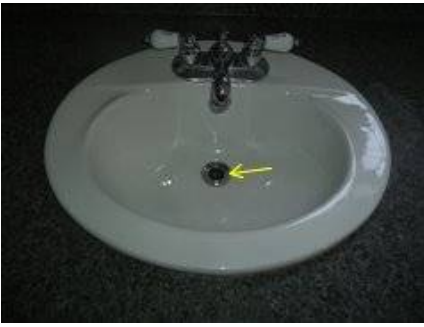
Photo 64-1
Bathroom

One or more sink or tub stopper mechanisms are missing, or need adjustment or repair. Stopper mechanisms should be installed where missing and/or repairs should be made so sink stoppers open and close easily.

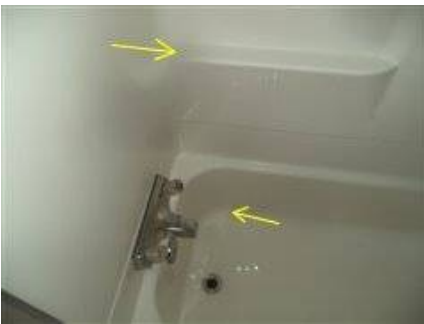
Photo 67-1
Bathroom

67) 🔍 The enamel coating on one or more bathtubs is damaged and/or deteriorated. For example, chipped or worn, and/or rust on some exposed steel. However, no leaks were found due to the deterioration. The client(s) should evaluate to determine if the bathtub(s) should be refinished or replaced.
