Home Inspection Report

Client(s): Bob Smith
Property address: 8525 Happy Ln.
Anytown, USA
Inspection date: Friday, August 01, 2014

Report number: SE082014A

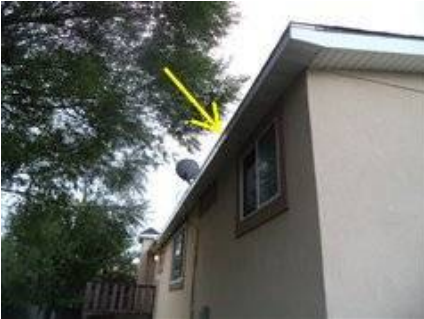
Photo 9-3
East side of home

- 9) 🛠️👁️ One or more gutters are missing. This can result in water accumulating around the structure's foundation, or in basements and crawl spaces if they exist. Accumulated water is a conducive condition to wood destroying insects and organisms, and may also cause the foundation to settle and possibly fail over time. Gutters and downspouts should be installed where missing. Also, extensions such as splashblocks or tie-ins to underground drain lines should be installed as necessary to carry rain water away from the house.
