Home Inspection Report

Client(s): Bob Smith
Property address: 8525 Happy Ln.
Anytown, USA
Inspection date: Friday, August 01, 2014

Report number: SE082014A

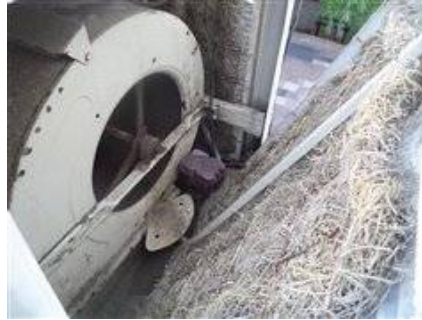
Photo 35-2

Roof, Interior of evaporative cooler

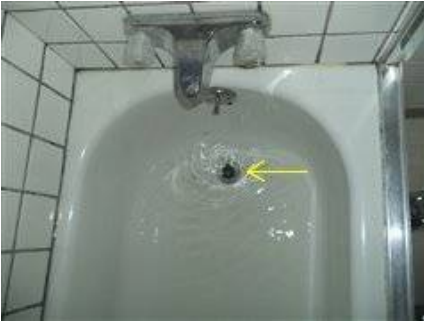
Photo 66-1
Bathroom

66) 🛠️ One or more bathtub drains are clogged or drain slowly. Drain(s) should be cleared as necessary, and by a qualified plumber if necessary.
